# SHELTER PROFILES

## ASSESSMENT OF PREPAREDNESS OF EMERGENCY SHELTERS ON GRAND BAHAMA AND THE ABACO ISLANDS FOR 2020 HURRICANE SEASON

THE BAHAMAS, MARCH 2020

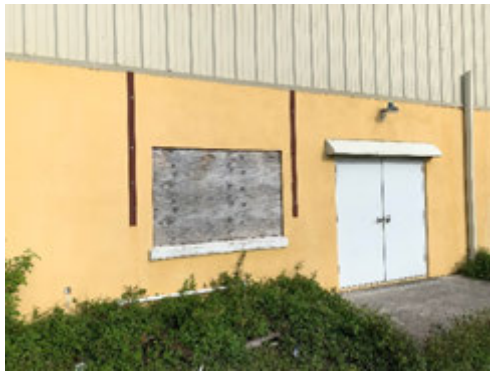
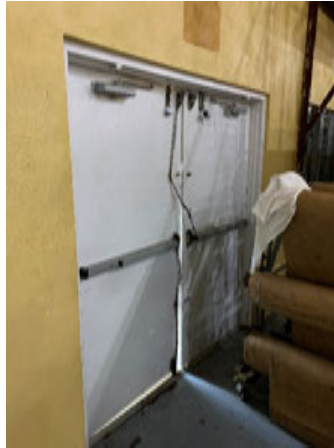
The building is not in excellent state of repair, with roof, door and window issues as illustrated by these photos.

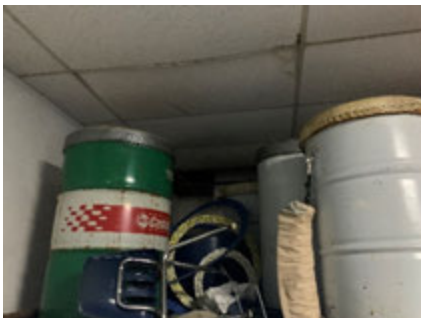
Minor leak in roof in corner of building

- Shelter was used during Dorian, but with 75 evacuees, it wasn't at the full capacity (why?) of 200.
- Shelter held up well to Dorian with no flooding, however there was a minor leak in the roof.
- In general, worked well. Robust building and good facilities (toilets, kitchen)

<b>For Emergency Centre (2-3 days)</b>	<b>For Collective Centre (3-6 months)</b>
<b>Short-term (2020 season)</b>	<ul style="list-style-type: none"> <li>Completion of roof repair after damage in Dorian.</li> <li>Ideally, emergency equipment and supplies stored on-site.</li> <li>The auditorium is the only designated shelter, but the school caters to 1100 students so has a great many classrooms that could act as a shelter to vastly more people. There were only a couple of rooms that sustained minor roof damage. On higher ground and did not flood.</li> </ul>	<ul style="list-style-type: none"> <li>This complex (including the classrooms) could act as a collective centre for a longer period of time, however it would disrupt the school and so is not recommended. Alternatively, the auditorium could be used for a longer period for a small capacity.</li> <li>Additional changes would need to be made to include more showers, and to check over the roofing.</li> </ul>

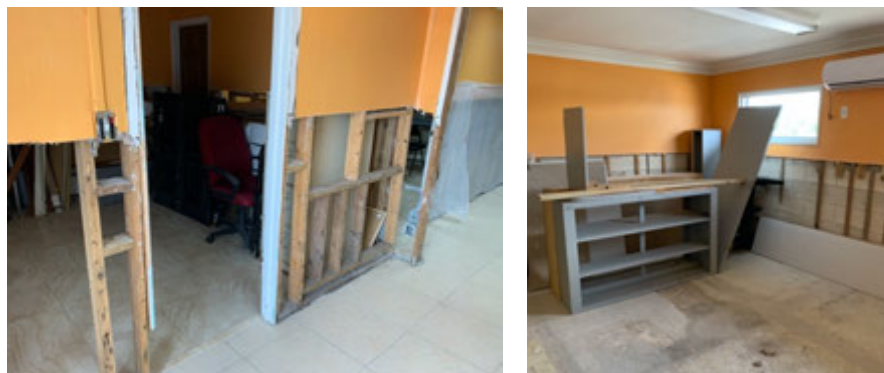
Extensive flood damage to building – shown by toilet and storage area being repaired.

<b>For Emergency Centre (2-3 days)</b>	<b>For Collective Centre (3-6 months)</b>
<b>Short-term (2020 season)</b>	<ul style="list-style-type: none"> <li>• Completion of building renovation after damage in Dorian (walls, flooring, toilet)</li> <li>• Re-kitting out kitchen with equipment and supplies</li> <li>• Additional fire extinguishers</li> <li>• New, more sophisticated telecoms system for better communication with EOC</li> <li>• Ideally, emergency equipment and supplies stored on-site.</li> </ul>	<ul style="list-style-type: none"> <li>• The building nominated for a shelter is 305m<sup>2</sup> and is quite separate from the main chapel. Capable of housing c. 75 people on a longer basis with some modifications (addition of showers) however there are better, larger options.</li> </ul>

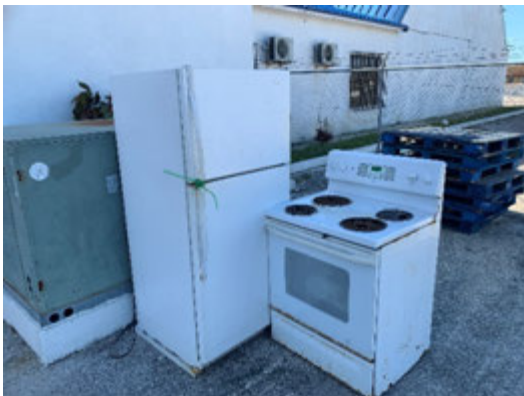
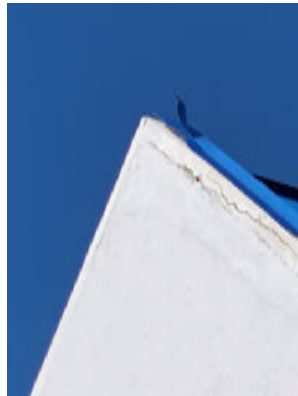
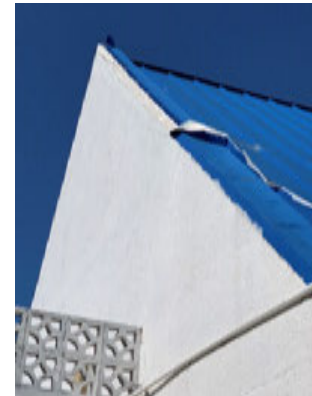
Church flooded causing damage to furniture and cooking equipment. Some minor roof damage.

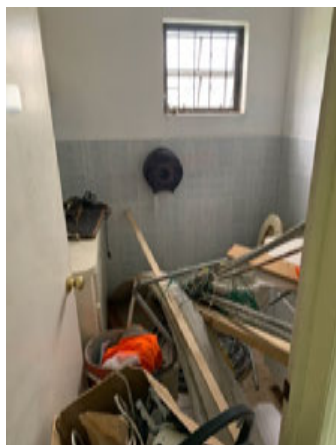
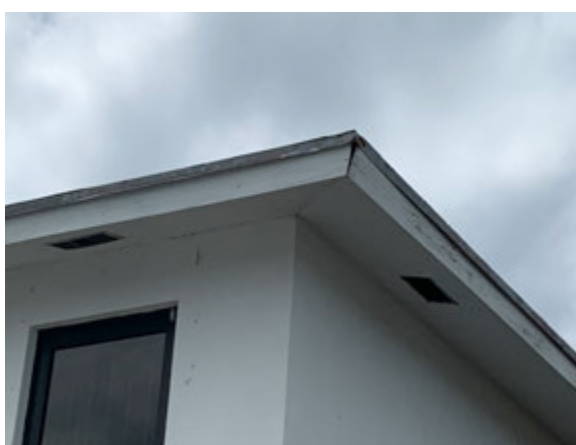
General low level of maintenance observed

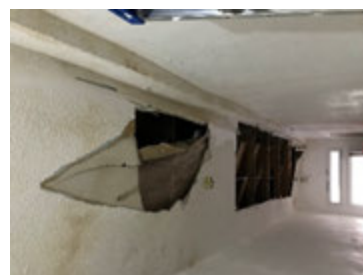
1. Damaged / leaking ceiling
2. Broken glass example (clear planes: replaced post Dorian)
3. Damaged ceiling in annex

- Church evacuated after 2 days due to water ingress through roof. Broken windows also occurred. 76 elderly people had to evacuate to another shelter.
- In community, there are areas of informal housing (Haitian migrants) which were not taken into account.

For Emergency Centre (2-3 days)	For Collective Centre (3-6 months)
<b>Short-term (2020 season)</b>	<ul style="list-style-type: none"> <li>Repairs to roof need to be completed to a high standard.</li> <li>Addition of ramp access for disabled would be beneficial.</li> <li>Strengthening of windows with reinforced glass is necessary.</li> <li>Training for church staff would be beneficial.</li> </ul>	<ul style="list-style-type: none"> <li>Not suitable for collective centre: <ul style="list-style-type: none"> <li>Capacity too small</li> <li>Chapel should not be used for collective centre, due to ongoing, community important use.</li> <li>Major upgrades to cooking, sanitation and disabled access would be required for a small</li> </ul> </li> </ul>

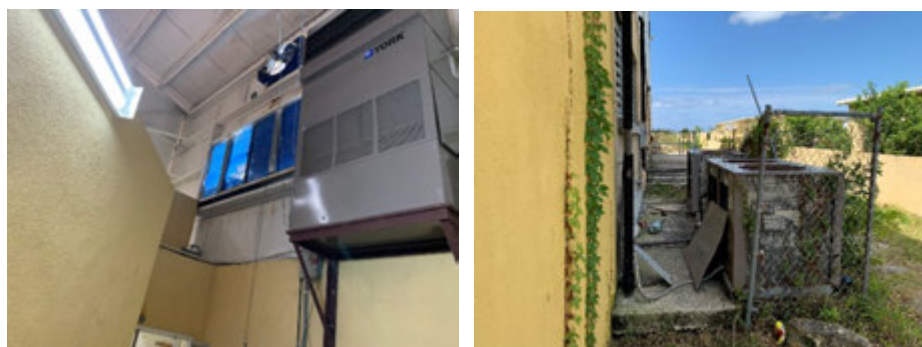
The additional building is not in excellent state of repair, as illustrated by these photos

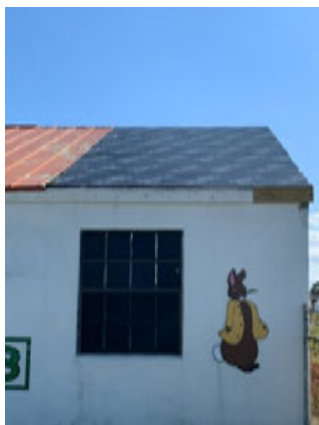
Community centre and chapel flooded causing severe damage to furniture; some minor roof damage

<b>For Emergency Centre (2-3 days)</b>	<b>For Collective Centre (3-6 months)</b>
<b>Short-term (2020 season)</b>	<ul style="list-style-type: none"> <li>Completion of building renovation after damage in Dorian to be completed</li> <li>Re-kitting out kitchen with equipment and supplies</li> <li>Transportation to be able to pick up people, especially from flooded areas</li> <li>Emergency lighting (solar lights / torches)</li> <li>Add fire extinguishers and medical kit</li> <li>New, more sophisticated telecoms system for better communication with EOC</li> <li>Ideally, emergency equipment and supplies stored on-site.</li> <li></li> </ul>	<ul style="list-style-type: none"> <li>The building nominated for a shelter is 170m<sup>2</sup>. Even after refurbishment, it could only house 50 people, so not recommended for a long-term solution on basis of economics of scale.</li> </ul>

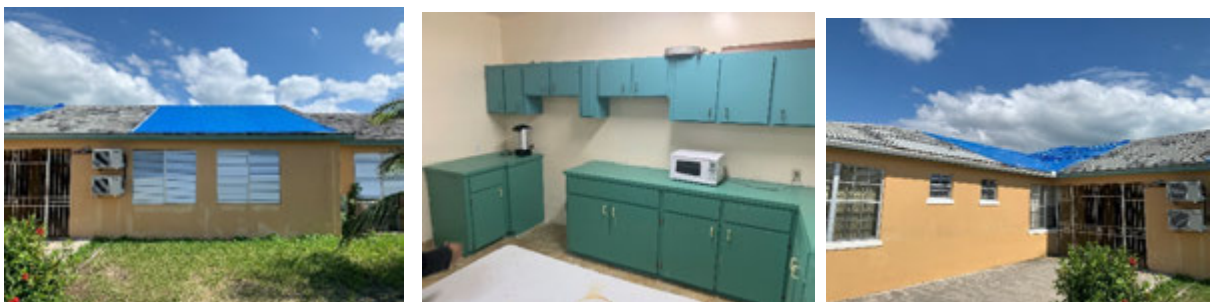
Multiple instances of roof damage still evident. Kitchen in process of being refitted but with very little equipment currently

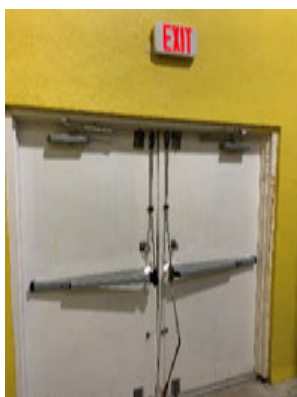
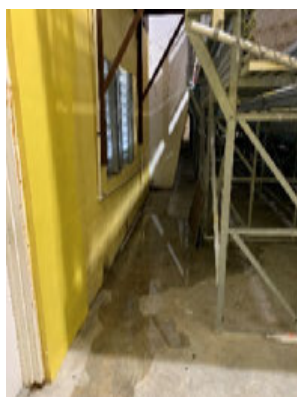
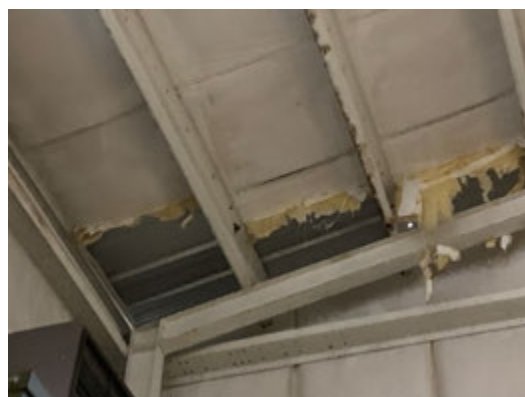
The building is in poor repair, evidenced by 1. Broken doors 2. Evidence of water ingress 3. Damaged roof

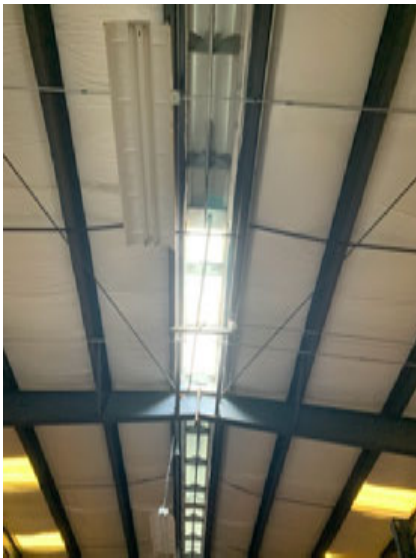
Minor damage to roof due to Dorian winds. Bright patch on picture is currently open to the elements

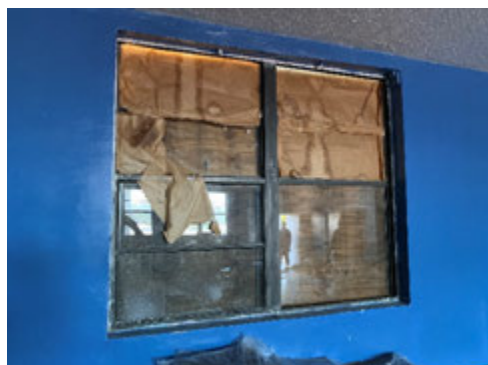
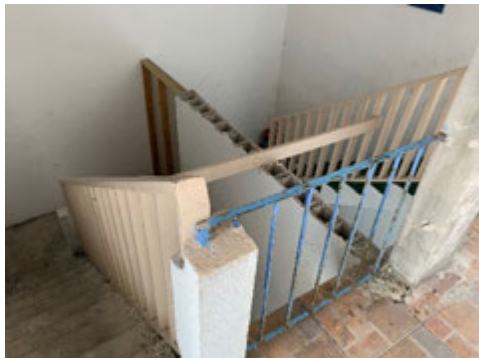
The additional building is not in excellent state of repair, as illustrated by these photos

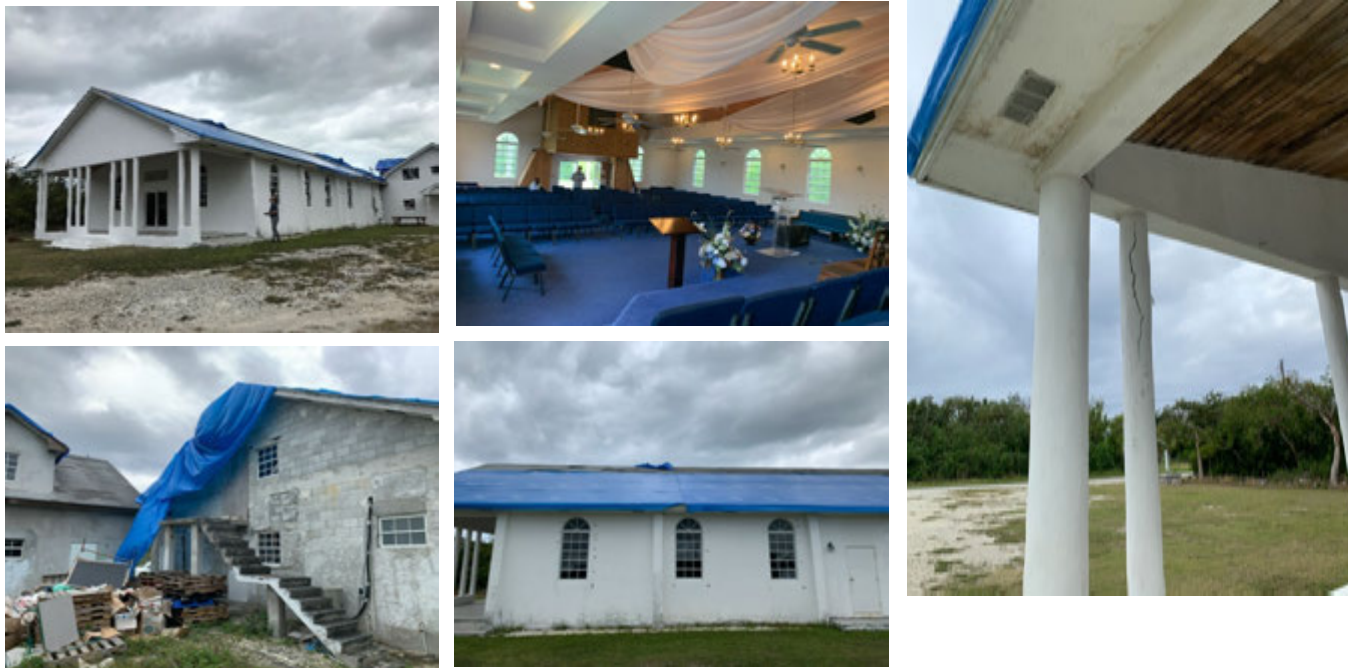
The building is not in excellent state of repair due to roof damage, and general lack of maintenance.

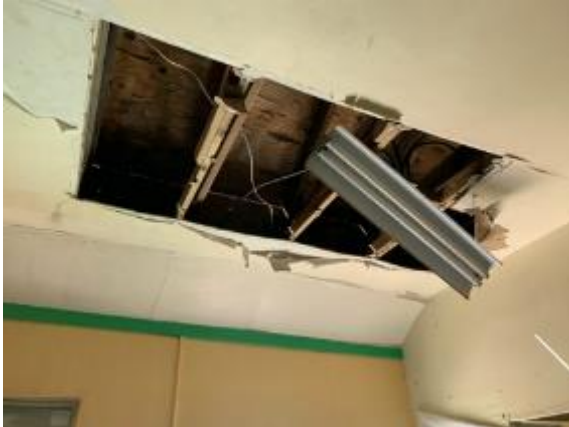
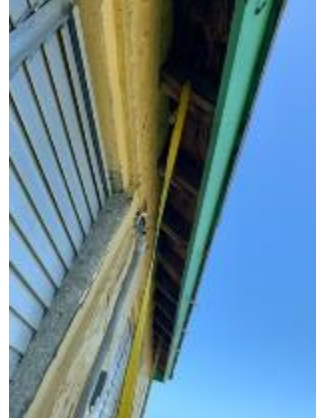
Damage to roof windows due to Dorian winds.

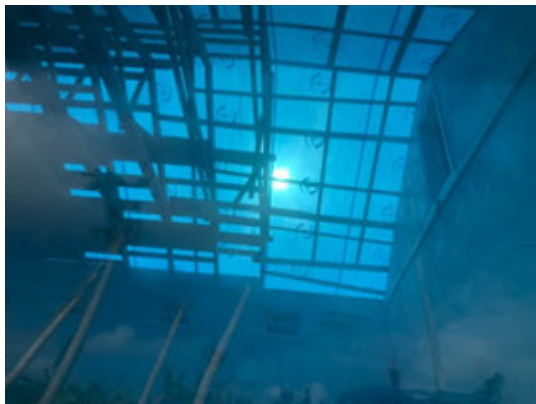
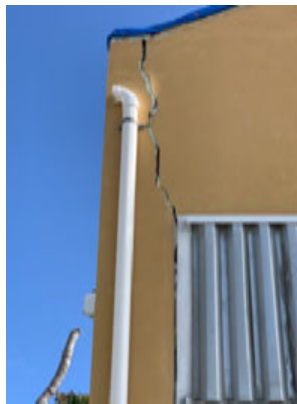
Major damage to roof. Minor damage to doors and windows due to Dorian winds. Structural issues.

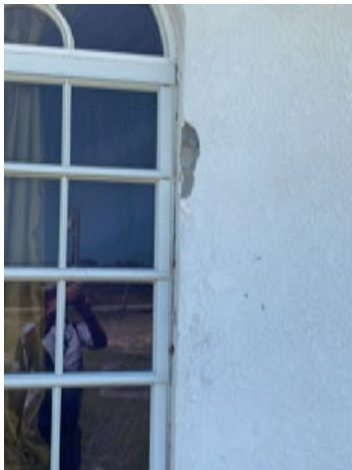
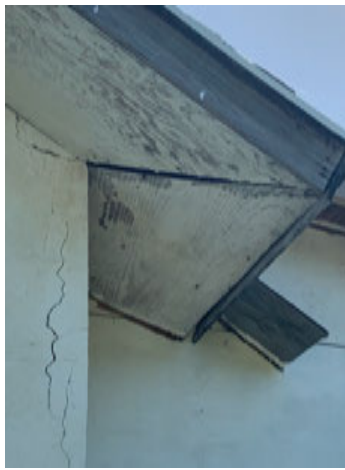
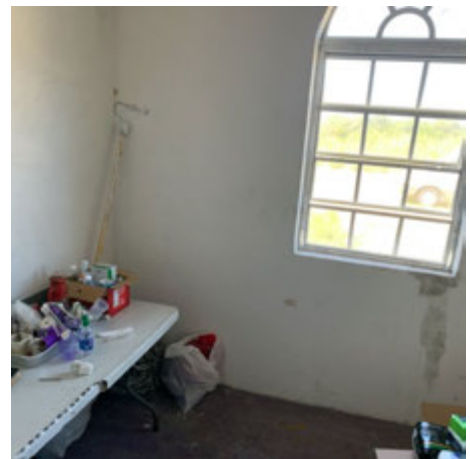
Minor damage to roof, doors and windows due to Dorian winds. General lack of maintenance

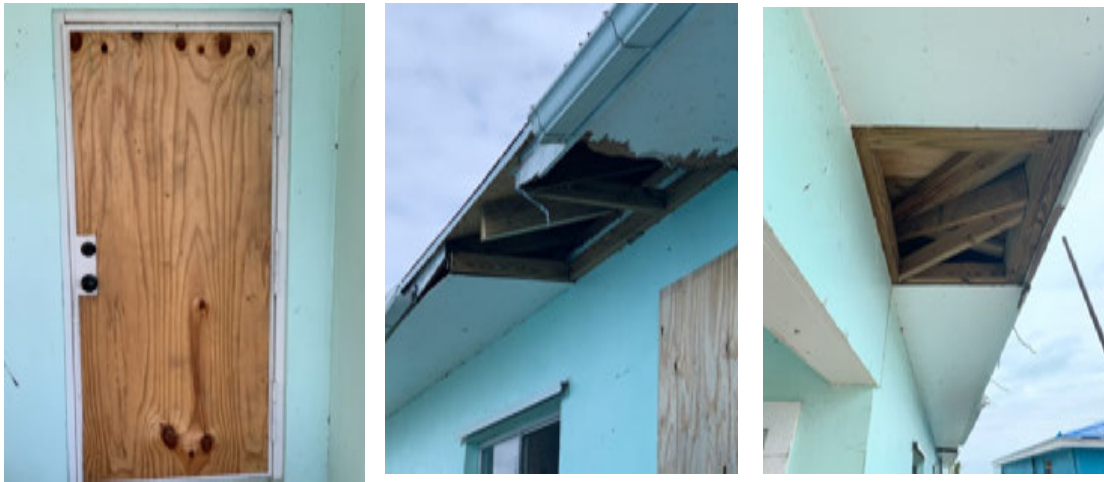
Minor damage to roof, doors and windows due to Dorian winds.

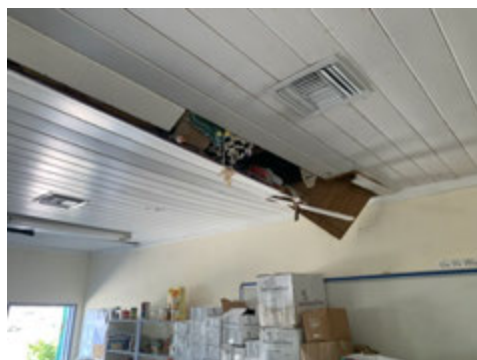
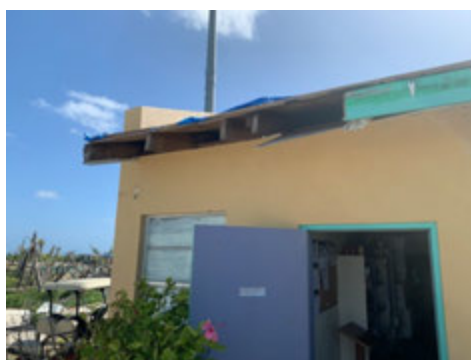
Damage to roof, doors and windows due to Dorian winds.

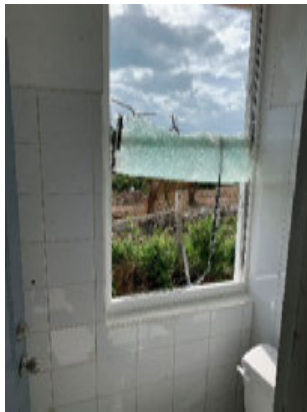
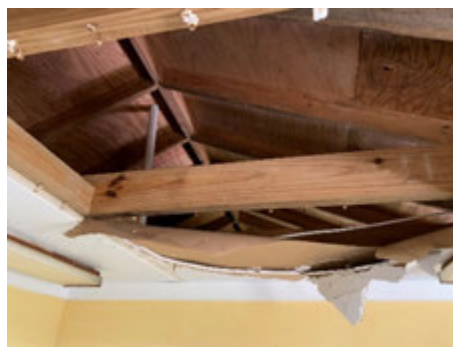
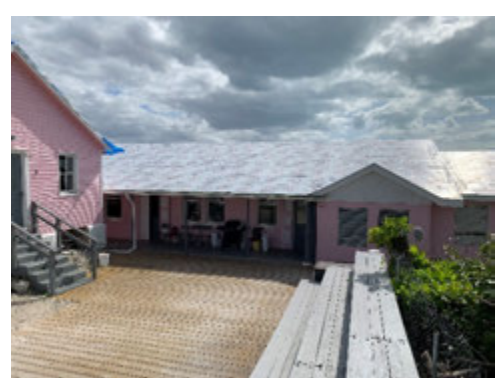
Extensive damage to all the buildings due to Dorian winds. All roofs either completely ripped off or severely damaged. Roof on main / newer building partially repaired. Many windows blown out.

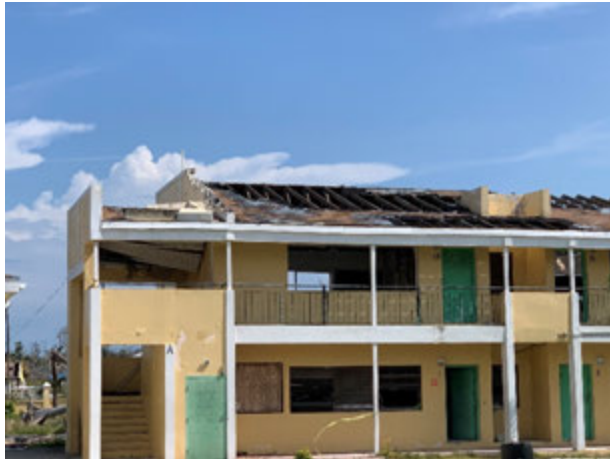
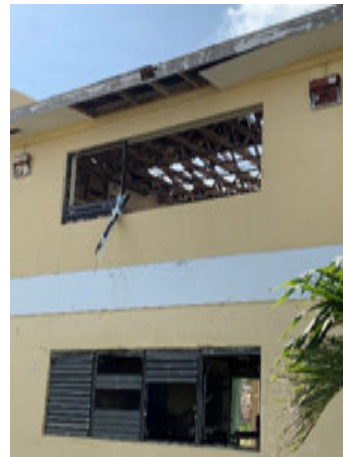
Extensive damage to all the buildings due to Dorian winds. All roofs either completely ripped off or severely damaged. Most windows blown out.

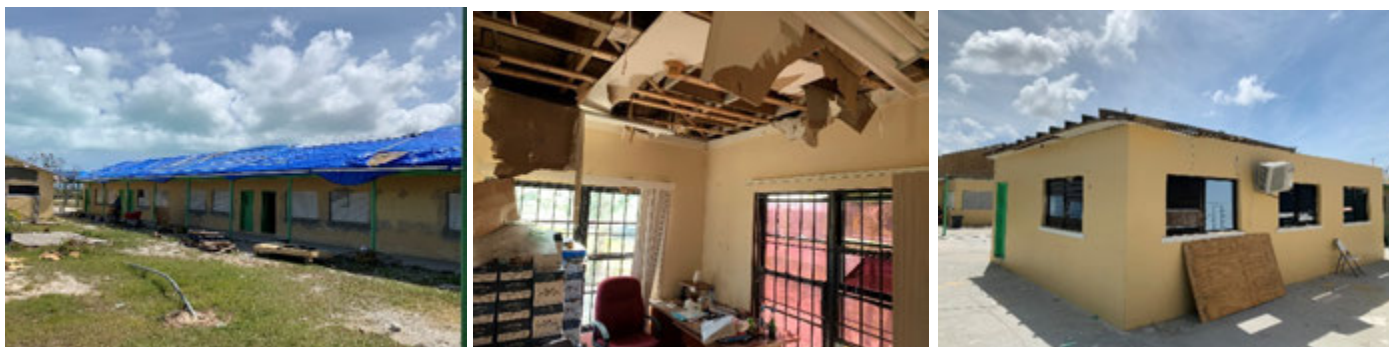
Extensive damage to all the buildings due to Dorian winds. All roofs either completely ripped off or severely damaged. Most windows, particularly at the back of the school, blown out.

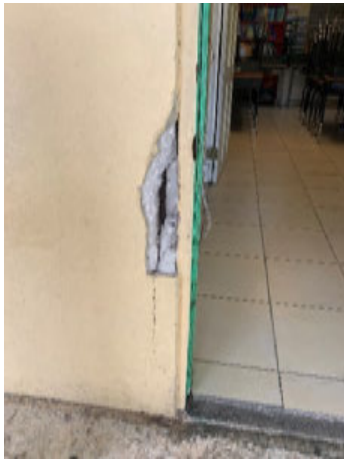
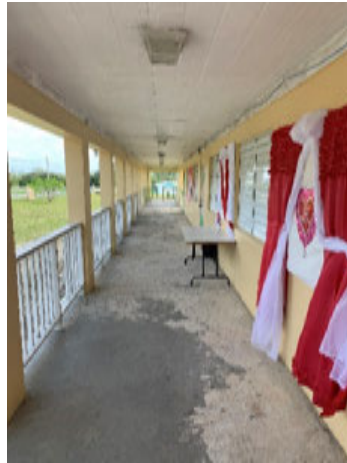
Minor structural damage outside one room (to be fixed). All rooms connected via an outside walkway.

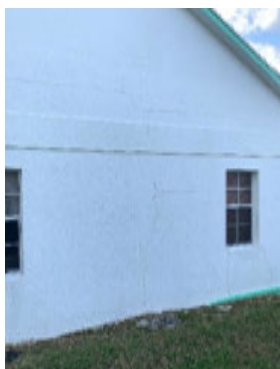
Building is in good shape, with minor damage to roof and a few leaks, which have been repaired. Some minor surface cracks at rear and front of building.

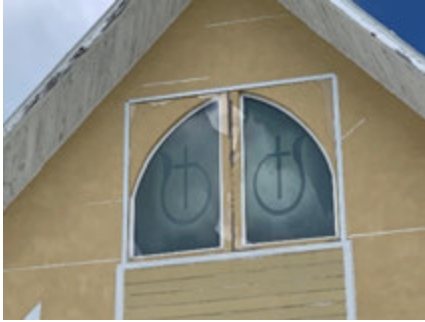
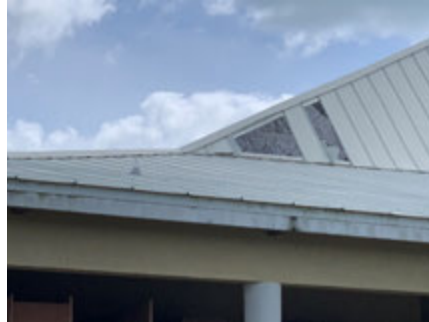
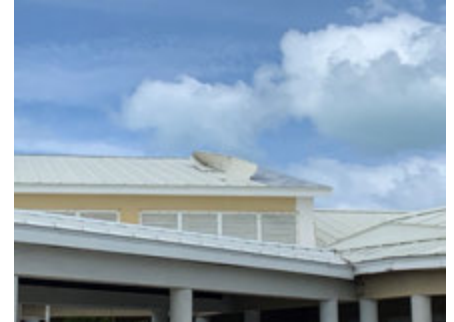
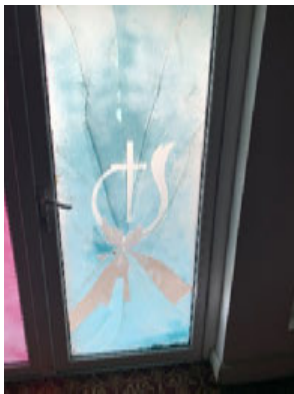
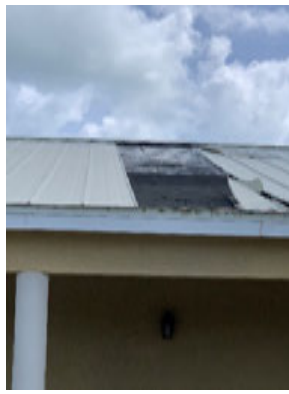
Minor damage to portions of the roof and windows due to Dorian winds. Main window above chapel leaks, causing water to drain into chapel.

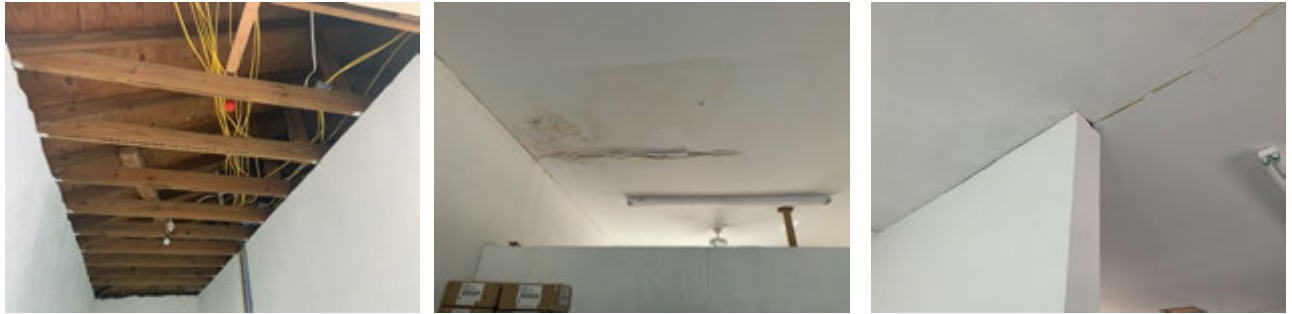
Minor damage to portions of the roof and windows due to Dorian winds. Main window above chapel leaks, causing water to drain into chapel.
