# SHELTER PROFILES

## ASSESSMENT OF PREPAREDNESS OF EMERGENCY SHELTERS ON GRAND BAHAMA AND THE ABACO ISLANDS FOR 2020 HURRICANE SEASON

THE BAHAMAS, MARCH 2020

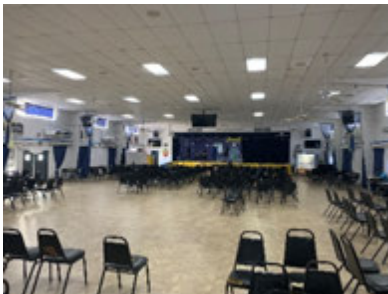
Minor leak in roof in corner of building

- Shelter was used during Dorian, but with 75 evacuees, it wasn't at the full capacity (why?) of 200.
- Shelter held up well to Dorian with no flooding, however there was a minor leak in the roof.
- In general, worked well. Robust building and good facilities (toilets, kitchen)

<b>For Emergency Centre (2-3 days)</b>	<b>For Collective Centre (3-6 months)</b>
<b>Short-term (2020 season)</b>	<ul style="list-style-type: none"> <li>Completion of roof repair after damage in Dorian.</li> <li>Ideally, emergency equipment and supplies stored on-site.</li> <li>The auditorium is the only designated shelter, but the school caters to 1100 students so has a great many classrooms that could act as a shelter to vastly more people. There were only a couple of rooms that sustained minor roof damage. On higher ground and did not flood.</li> </ul>	<ul style="list-style-type: none"> <li>This complex (including the classrooms) could act as a collective centre for a longer period of time, however it would disrupt the school and so is not recommended. Alternatively, the auditorium could be used for a longer period for a small capacity.</li> <li>Additional changes would need to be made to include more showers, and to check over the roofing.</li> </ul>

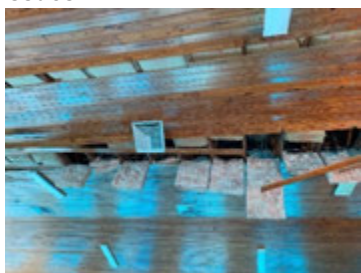
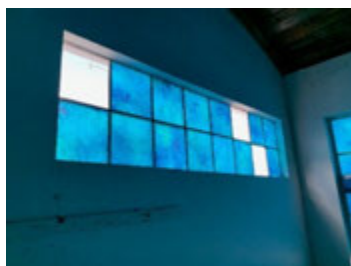
1. Damaged / leaking ceiling
2. Broken glass example (clear planes: replaced post Dorian)
3. Damaged ceiling in annex

For Emergency Centre (2-3 days)	For Collective Centre (3-6 months)
<b>Short-term (2020 season)</b>	<ul style="list-style-type: none"> <li>Repairs to roof need to be completed to a high standard.</li> <li>Addition of ramp access for disabled would be beneficial.</li> <li>Strengthening of windows with reinforced glass is necessary.</li> <li>Training for church staff would be beneficial.</li> </ul>	<ul style="list-style-type: none"> <li>Not suitable for collective centre: <ul style="list-style-type: none"> <li>Capacity too small</li> <li>Chapel should not be used for collective centre, due to ongoing, community important use.</li> <li>Major upgrades to cooking, sanitation and disabled access would be required for a small</li> </ul> </li> </ul>

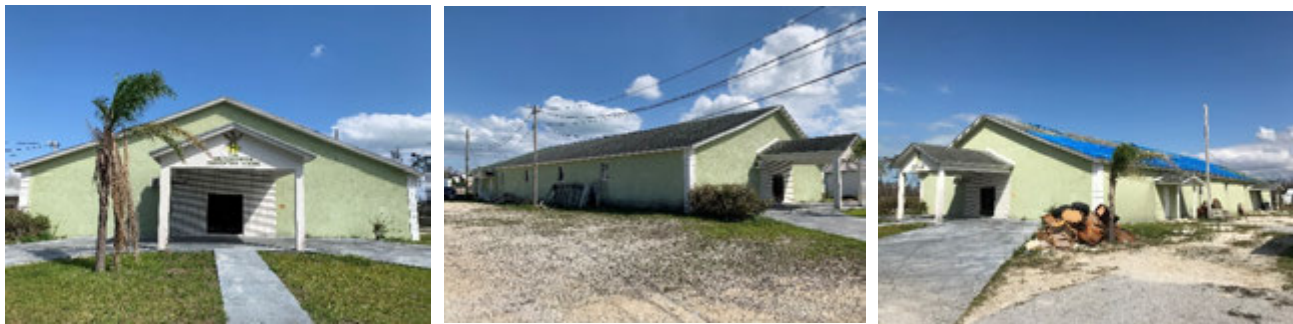
- With a nominated capacity of 150, the shelter quickly became flooded after the arrival of Dorian, and also received roof damage. Evacuees had to flee in the middle of the storm to seek safe refuge elsewhere.
- The facility is clearly not currently in a state to act as a shelter currently, and needs renovation, particularly the roof.
- The centre is well situated for the local population however is not really large.
- The building needs to be repaired to a higher quality than before, with pre-positioned equipment and supplies to act as an evacuation shelter for a small group.
- Not suitable for a long-term shelter due to size.

<b>Roof</b>	Gable Shingle roof, fared badly during Dorian with many leaks.	<b>Windows/Shutters</b>	Plain glass with shutters on some windows.
<b>Comms</b>	VHF radio delivered before Dorian but didn't work during storm. Irregular cell phone signal.	<b>Disability Access</b>	Yes

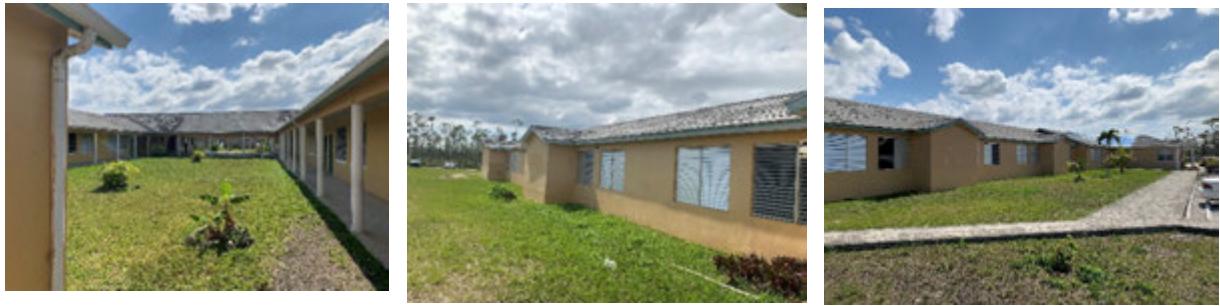
Multiple instances of roof damage still evident. Kitchen in process of being refitted but with very little equipment currently

- The school is nominated to handle all evacuees from East Grand Bahama, with a population of 10,000 and a capacity of 400 it is woefully inadequate.
- The school was badly compromised during Dorian, with flooding and roof damage. The whole population of the school ended up fleeing mid storm.
- Needs repairing to a higher standard, in particular the roofing. It also needs pre-positioned equipment and supplies to act as an evacuation shelter.
- Not suitable for a long-term shelter.

For Emergency Centre (2-3 days)	For Collective Centre (3-6 months)
<b>Short-term (2020 season)</b>	<ul style="list-style-type: none"> <li>Completion of roof renovation after damage in Dorian.</li> <li>Re-kitting out kitchen with equipment and supplies</li> <li>Transportation to be able to pick up people, especially from flooded areas</li> <li>Emergency lighting (solar lights / torches)</li> <li>Additional fire extinguishers and medical kit</li> <li>New, more sophisticated telecoms system for better communication with EOC</li> <li>Ideally, emergency equipment and supplies stored on-site.</li> </ul>	<ul style="list-style-type: none"> <li>The building did not cope well during Dorian (flooding and roof damage) and the population evacuated. The facility is very large though and has c. 30 classrooms, providing c. 1900 m<sup>2</sup> (500 people at 3.5m<sup>2</sup> per person) of living space. Although disruptive to school, could be used as a collective centre for a slightly longer time (1 month ?) although this would be disruptive in trying to get the school back up and running. Significant improvements would need to be made including: <ul style="list-style-type: none"> <li>Addition of showers</li> <li>Significant increase in cooking and dining facilities</li> </ul> </li> </ul>

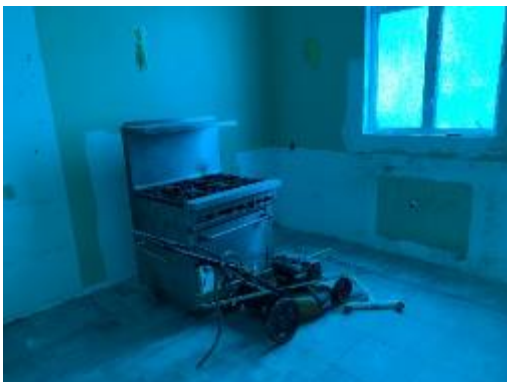
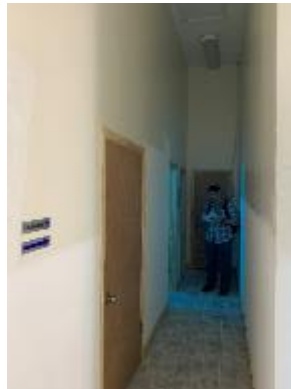
1.Kitchen needs refitting, 2. Toilet / storerooms in process of being renovated

- The church and community centre got flooded during Dorian, with evacuees needing to huddle on the small chapel stage for 2-3 days. Damage to bathroom and kitchen in need of repair.
- Needs pre-positioned equipment and supplies to act as an evacuation shelter.
- Not suitable for a long-term shelter.

For Emergency Centre (2-3 days)	For Collective Centre (3-6 months)
<b>Short-term (2020 season)</b>	<ul style="list-style-type: none"> <li>Completion of building renovation after damage in Dorian (carpet), renovating toilets and kitchen.</li> <li>Re-kitting out kitchen with equipment and supplies</li> <li>Transportation to be able to pick up people, especially from flooded areas</li> <li>Emergency lighting (solar lights / torches)</li> <li>Additional fire extinguishers and medical kit</li> <li>New, more sophisticated telecoms system for better communication with EOC</li> <li>Ideally, emergency equipment and supplies stored on-site.</li> </ul>	<ul style="list-style-type: none"> <li>The building nominated for a shelter is 130m<sup>2</sup>. Even after refurbishment, it could only house 35 people, so not recommended for a long-term solution on basis of economics of scale.</li> </ul>

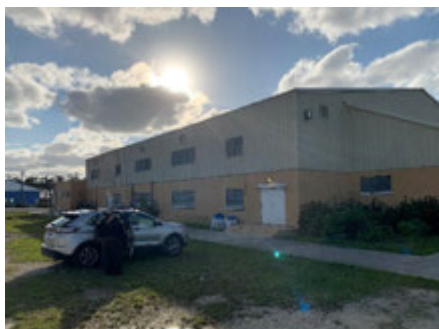
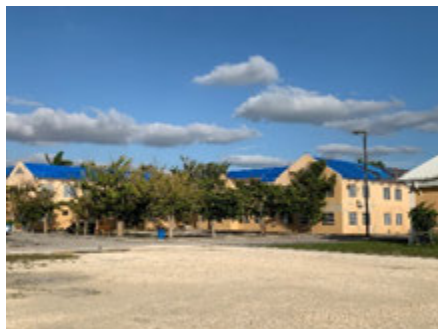
The building is in poor repair, evidenced by 1. Broken doors 2. Evidence of water ingress 3. Damaged roof

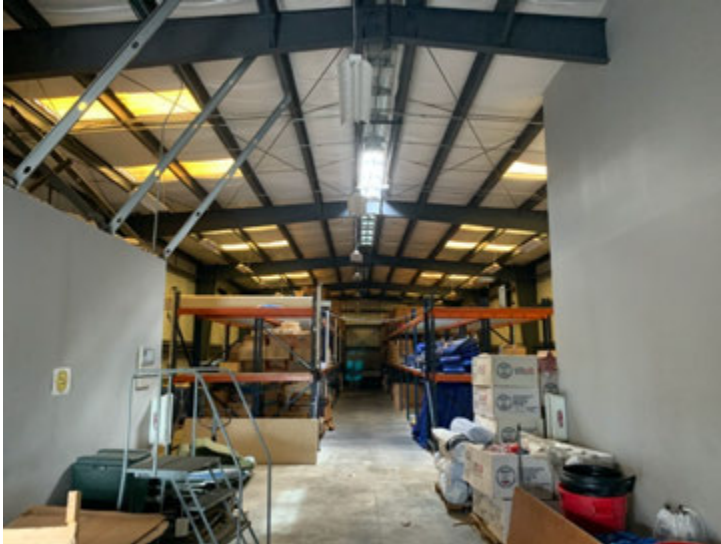
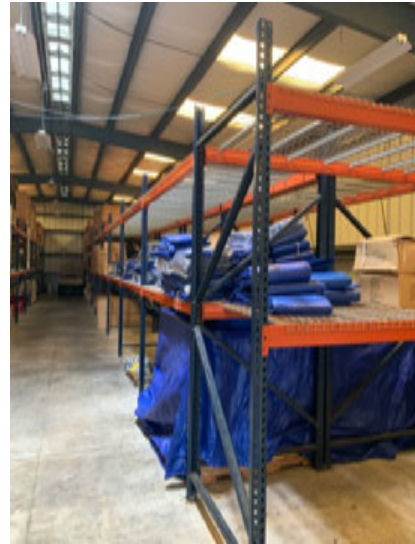
Minor damage to roof due to Dorian winds. Bright patch on picture is currently open to the elements

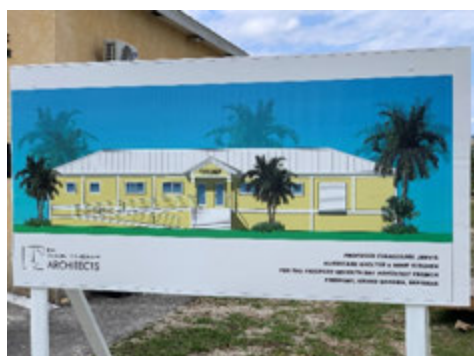
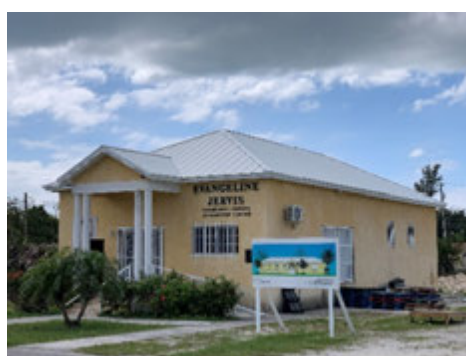
Other :

Wall/roof at one end of evacuee room caved in during Dorian causing significant damage needing wall, roof, floor, kitchen replacement

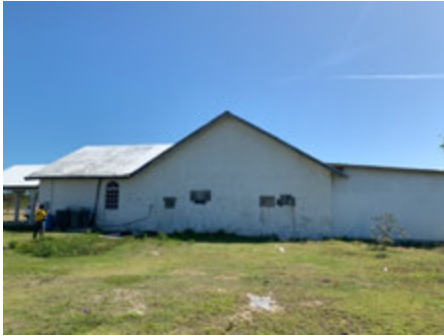
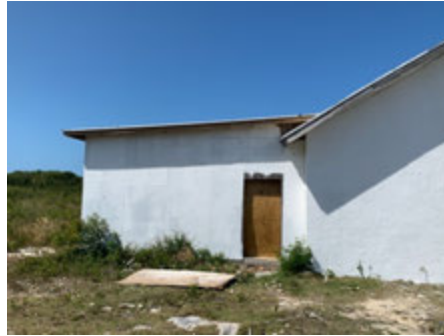
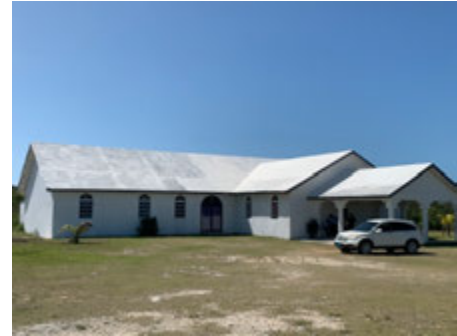
**Exterior:**

Minor damage to roof, doors and windows due to Dorian winds. General lack of maintenance

For Emergency Centre (2-3 days)	For Collective Centre (3-6 months)
<b>Short-term (2020 season)</b>	<ul style="list-style-type: none"> <li>Completion of minor building renovation after damage in Dorian (roofing, windows, structural repairs).</li> <li>Add water tank/pump/filtration system.</li> <li>Emergency lighting (solar lights / torches) recommended.</li> <li>New, more sophisticated telecoms system for better communication with EOC</li> <li>Ideally, emergency equipment and supplies stored on-site.</li> </ul>	<ul style="list-style-type: none"> <li>With the building being an operational church, this would be at the expense of the chapel operating, and is therefore not advisable.</li> </ul>

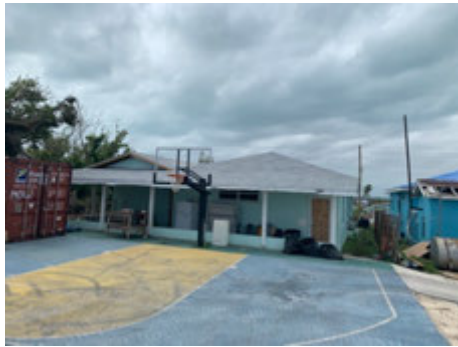
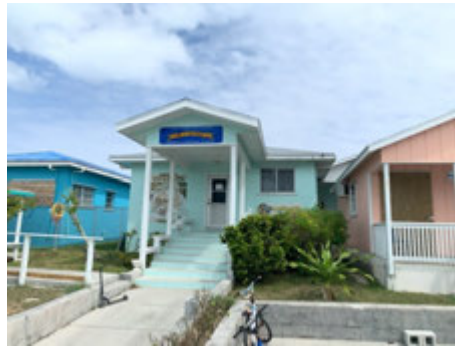
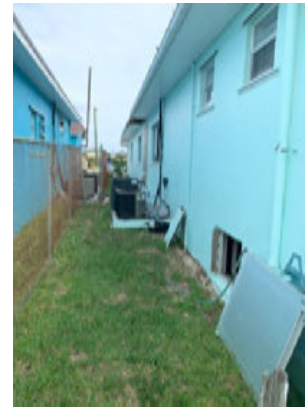
**Exterior:**

Minor damage to roof, doors and windows due to Dorian winds.

- The shelter, with a capacity of 40, housed 6 people during Dorian. Some minor damage to the roof, windows and doors caused leaking but on the whole the building stayed together reasonably well.
- The shelter had to be very self-sufficient. No govt personnel came to manage it, and no equipment or supplies were sent. Post Dorian, the community have been left to try and make repairs.
- No reported protection issues.
- No ability to communicate with EOC.

<b>For Emergency Centre (2-3 days)</b>	<b>For Collective Centre (3-6 months)</b>
<b>Short-term (2020 season)</b>	<ul style="list-style-type: none"> <li>• Completion of building renovation after damage in Dorian (roofing, windows, structural repairs).</li> <li>• Add water pump/filtration system.</li> <li>• Emergency lighting (solar lights / torches) recommended.</li> <li>• New, more sophisticated telecoms system for better communication with EOC</li> <li>• Ideally, emergency equipment and supplies stored on-site.</li> </ul>	<ul style="list-style-type: none"> <li>• With the building being on the small side, and being a school, this would be at the expense of the school operating and not taking advantage of economies of scale, and is therefore not advisable.</li> </ul>

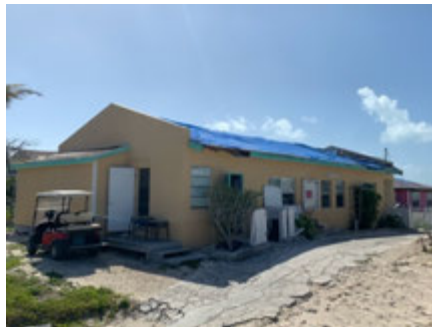
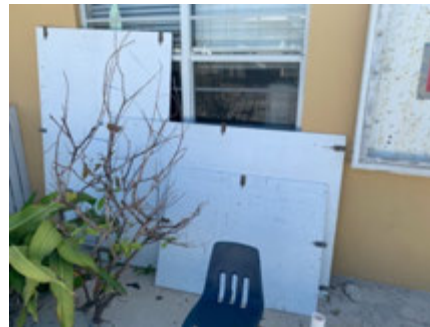
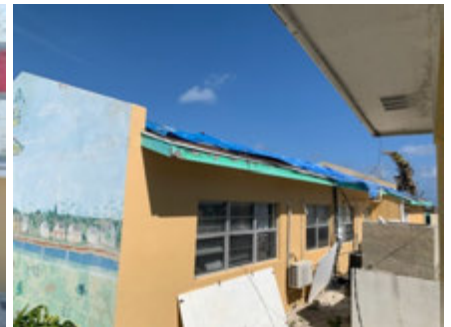
# Exterior:

Damage to roof, doors and windows due to Dorian winds.

- Roof, doors and some windows were damaged, allowing water ingress.
- 12 people used the shelter during Dorian. The shelter had to be very self-sufficient. No govt personnel came to manage it, and no equipment or supplies were sent. Post Dorian, the community have been left to try and make repairs.

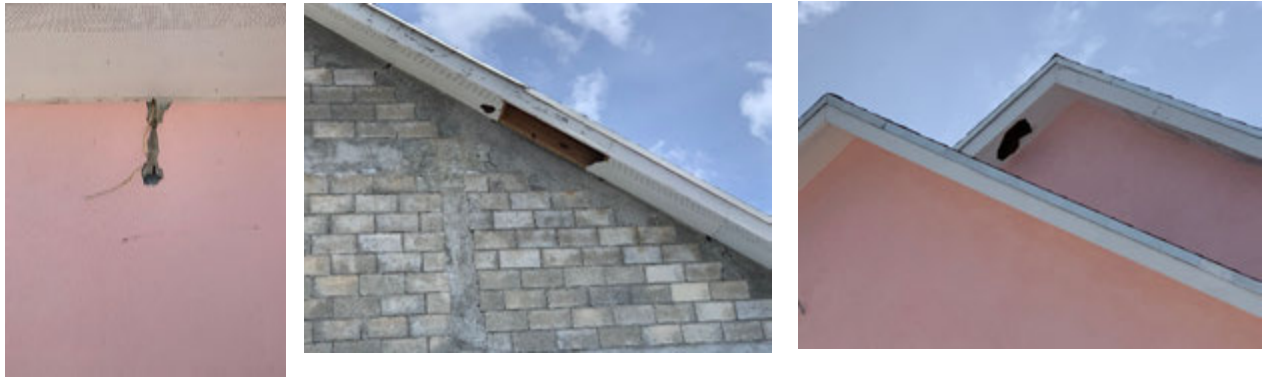
In addition to renovation of the kitchen and meeting areas to the back of the church, there are minor structural issues to walls and roof.

<b>For Emergency Centre (2-3 days)</b>	<b>For Collective Centre (3-6 months)</b>
<b>Short-term (2020 season)</b>	<ul style="list-style-type: none"> <li>• Whilst the building, with some renovation, is a good size and could be used as an emergency shelter, it is situated in an area that floods, and is likely to be severely compromised during a hurricane.</li> <li>• It is not recommended as an emergency centre. But could be used as a back-up if it's clear the area will not flood.</li> <li>• In that case, it needs to be much better equipped.</li> </ul>	<ul style="list-style-type: none"> <li>• Although the building is large enough for a collective centre, given it is in an area prone to flooding, and is an operating church, it is not advisable.</li> </ul>

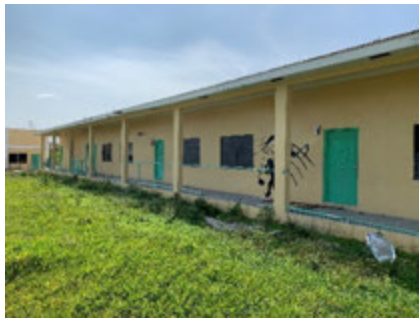
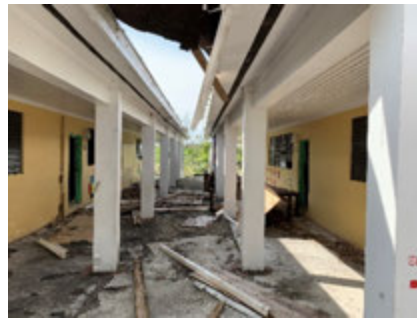
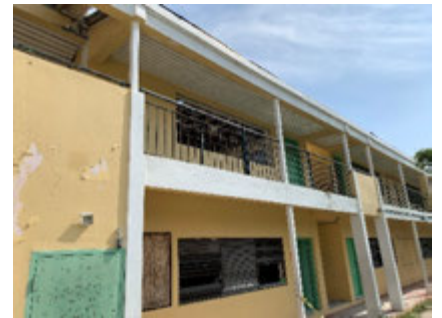
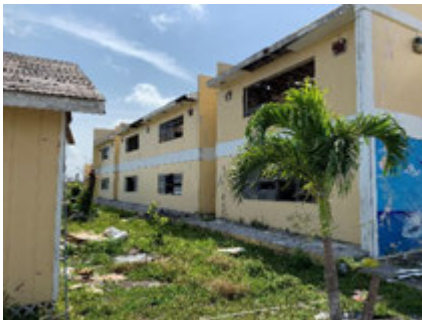
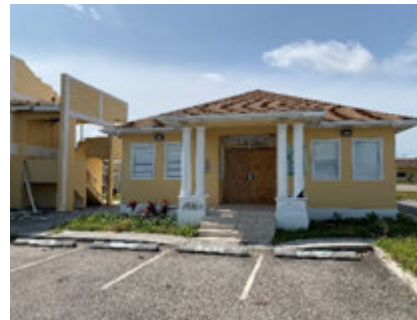
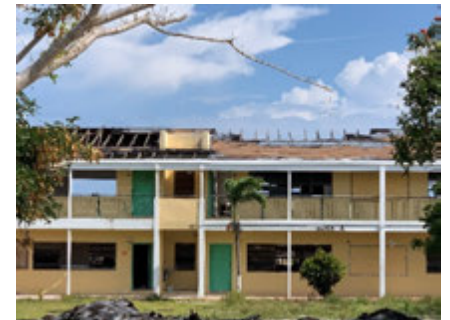
Extensive damage to all the buildings due to Dorian winds. All roofs either completely ripped off or severely damaged. Most windows blown out.

- The school was not used during Dorian.
- The roof was severely damaged, and windows blown out during Dorian

<b>For Emergency Centre (2-3 days)</b>	<b>For Collective Centre (3-6 months)</b>
<b>Short-term (2020 season)</b>	<ul style="list-style-type: none"> <li>• Renovate building after damage in Dorian (roofing, windows, structural repairs, electrical and plumbing repairs).</li> <li>• Re-kitting out kitchen with equipment and supplies.</li> <li>• Transportation to be able to pick up people would be advantageous.</li> <li>• Emergency lighting (solar lights / torches) recommended.</li> <li>• Additional fire extinguishers and medical kit need replacing.</li> <li>• New, more sophisticated telecoms system for better communication with EOC</li> <li>• Ideally, emergency equipment and supplies stored on-site.</li> </ul>	<ul style="list-style-type: none"> <li>• Although the building is large enough and potentially well enough equipped for a collective centre, given it is a school, this would be at the expense of the school operating, and is therefore not advisable.</li> </ul>

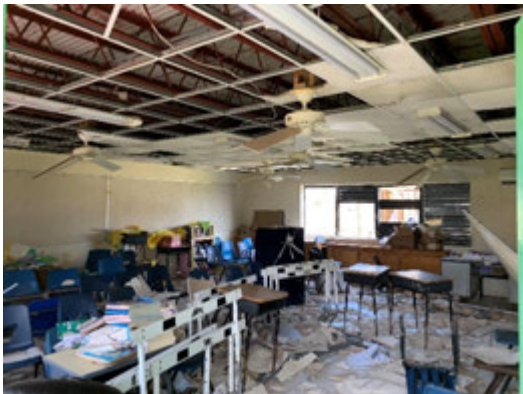
27 classrooms of 8.1m x 7.2m (60m<sup>2</sup>). All with extensive damage as above.

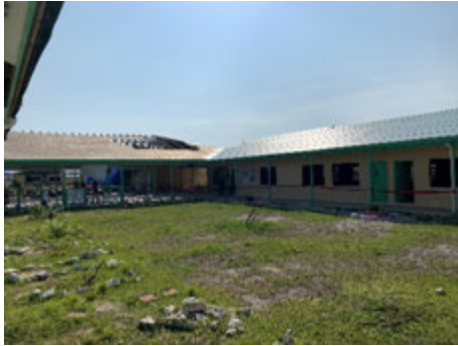
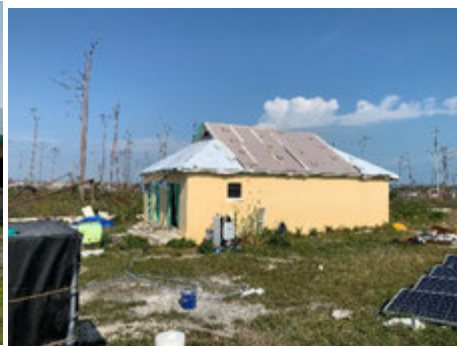
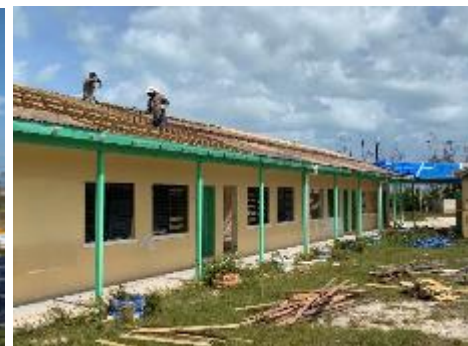
Extensive damage to all the buildings due to Dorian winds. All roofs either completely ripped off or severely damaged. Most windows, particularly at the back of the school, blown out.

<b>For Emergency Centre (2-3 days)</b>	<b>For Collective Centre (3-6 months)</b>
<b>Short-term (2020 season)</b>	<ul style="list-style-type: none"> <li>• Completion of building renovation after damage in Dorian (roofing, windows, structural repairs, electrical and plumbing repairs).</li> <li>• Re-kitting out kitchen with equipment and supplies.</li> <li>• Transportation to be able to pick up people would be advantageous.</li> <li>• Emergency lighting (solar lights / torches) recommended.</li> <li>• Additional fire extinguishers and medical kit required</li> <li>• New, more sophisticated telecoms system for better communication with EOC</li> <li>• Ideally, emergency equipment and supplies stored on-site.</li> </ul>	<ul style="list-style-type: none"> <li>• Although the building is large enough and potentially well enough equipped for a collective centre, given it is a school, this would be at the expense of the school operating, and is therefore not advisable.</li> </ul>

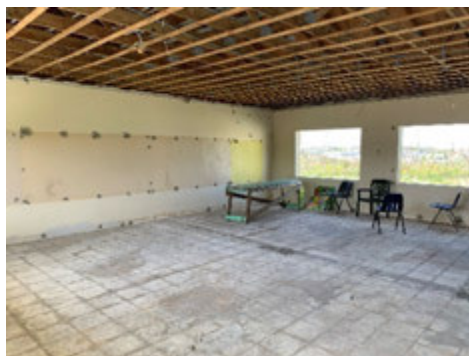
32 classrooms of 8.7m x 7.2m (60m<sup>2</sup>), currently being reconstructed. 10 classrooms expected to be ready end-April.

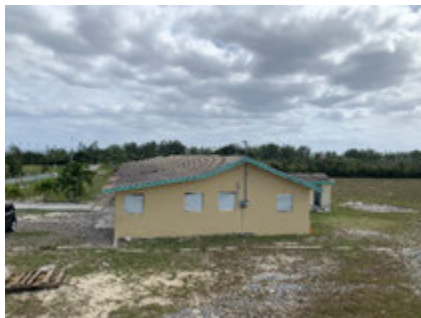
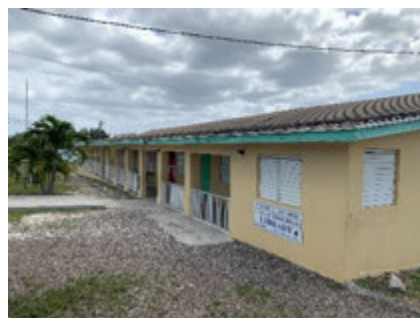
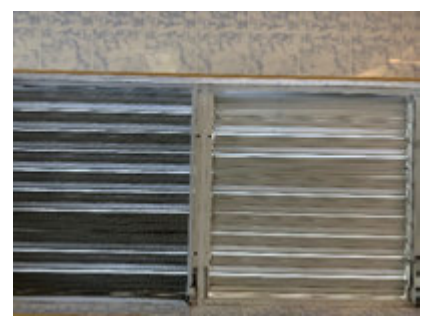
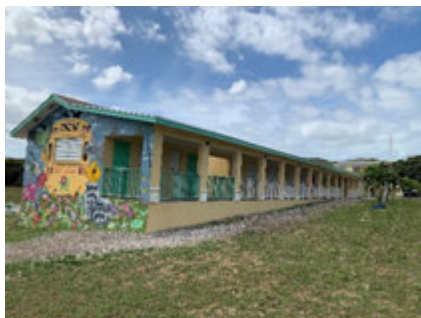
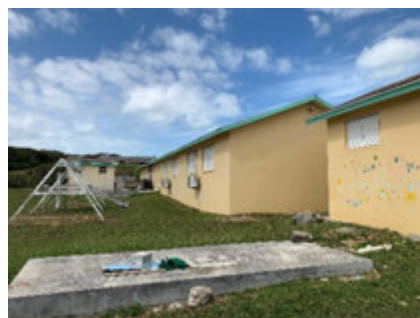
Minor structural damage outside one room (to be fixed). All rooms connected via an outside walkway.

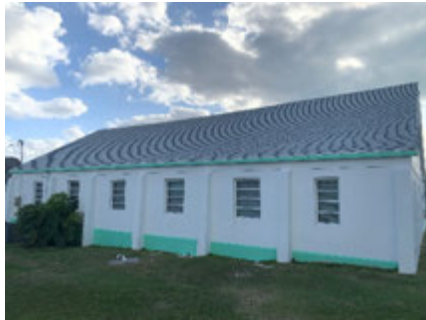
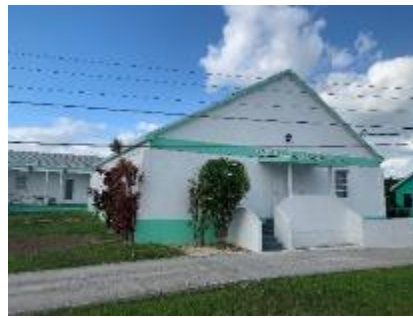
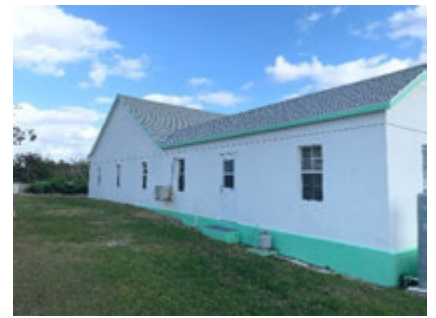
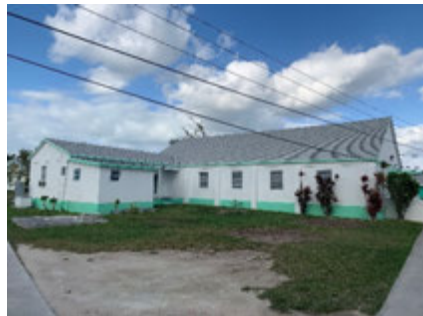
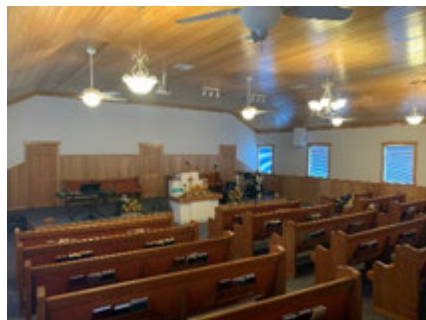
Building is in good shape, with minor damage to roof and a few leaks, which have been repaired. Some minor surface cracks at rear and front of building.

- The shelter opened and was used by c. 20 people during Dorian. The roof received some minor damage (a few shingles came off) and there was some minor leaks, but it held up quite well.
- The shelter was not managed by anyone, and had no supplies or equipment delivered. There was no generator and no communications equipment.

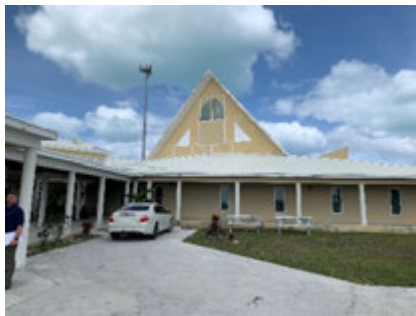
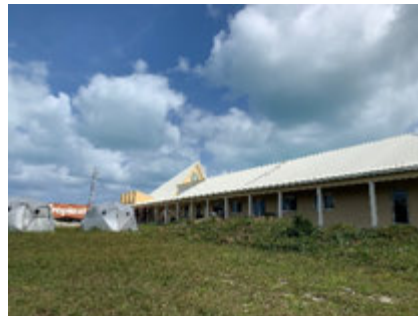
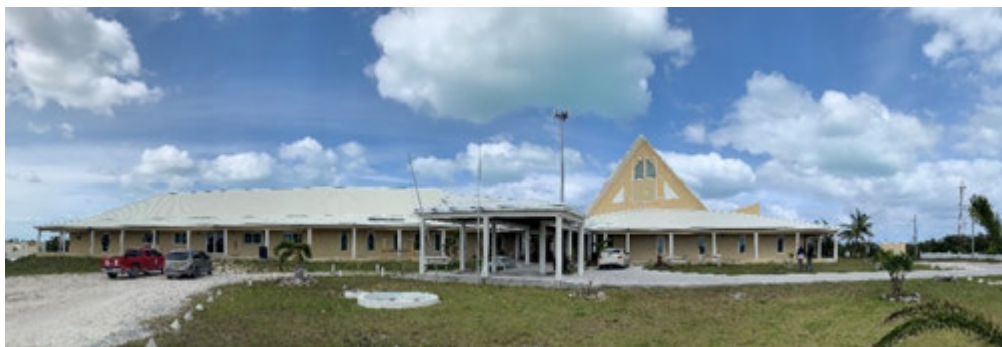
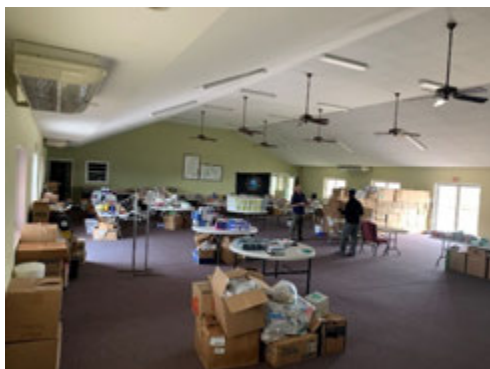
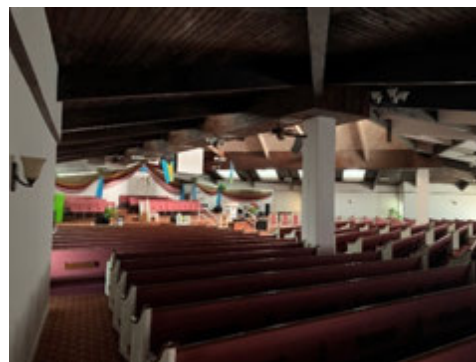
Minor damage to portions of the roof and windows due to Dorian winds. Main window above chapel leaks, causing water to drain into chapel.

- With a nominated capacity of 200, the shelter was popular with local residents. Once past 45 registration ceased and there were issues with septic tanks. No defence force or medical staff were in attendance.
- Despite this, the shelter worked ok, with a strong building, and good equipment (generator, water supply, toilets, showers etc). Additional equipment – solar lights, additional kitchen equipment, fire extinguishers and medical supplies – would be good.
- Minor roof and window/door damage.
- No ability to communicate with EOC.

<b>For Emergency Centre (2-3 days)</b>	<b>For Collective Centre (3-6 months)</b>
<ul style="list-style-type: none"> <li>Building requires some investment in repairing roof, doors and windows – to a higher quality than before.</li> <li>Upgrade kitchen equipment and supplies</li> <li>Emergency lighting (solar lights / torches) recommended.</li> <li>Fire extinguishers and medical kit required</li> <li>New, more sophisticated telecoms system for better communication with EOC</li> <li>Ideally, emergency equipment and supplies stored on-site.</li> </ul>	<ul style="list-style-type: none"> <li>The building is large enough and potentially well enough equipped for a small collective centre, for c. 100 people.</li> <li>Upgrade of certain equipment (outlined for emergency shelter) required.</li> </ul>

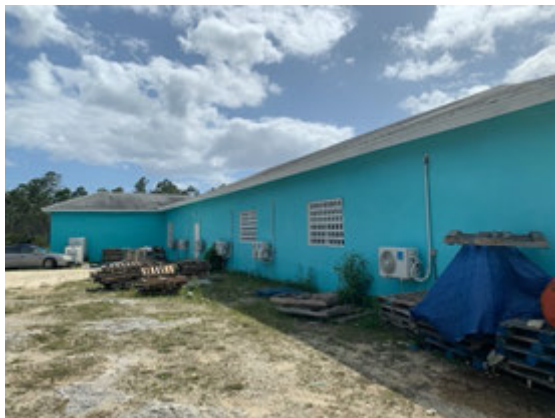
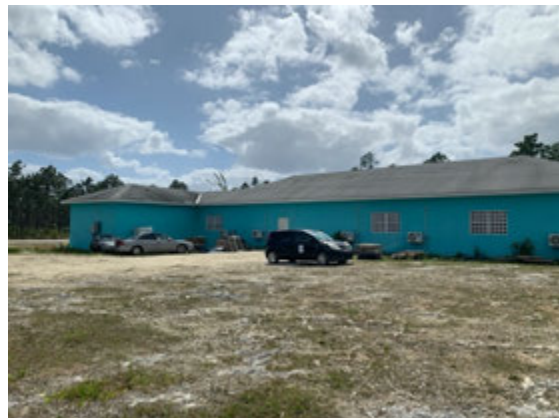
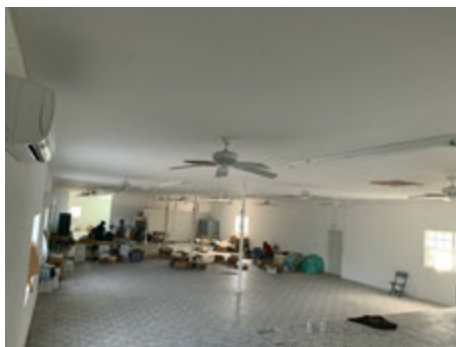
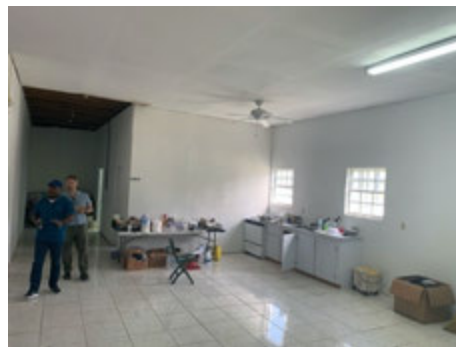
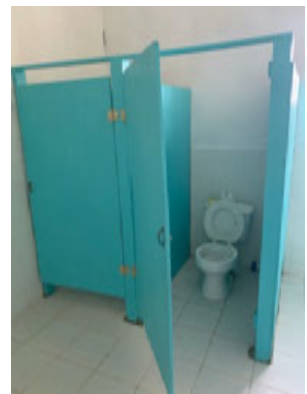
Minor damage to portions of the roof and windows due to Dorian winds. Main window above chapel leaks, causing water to drain into chapel.

- With a nominated capacity of 200, the shelter was used by about 115 people.
- The shelter worked ok, with a strong building, minor roof damage and leaks.
- Frailties showed themselves in a lack of equipment – no generator, water supply, insufficient toilets, no showers, kitchen capacity not enough etc.
- Additional equipment – solar lights, additional kitchen equipment, fire extinguishers and medical supplies – would be good.
